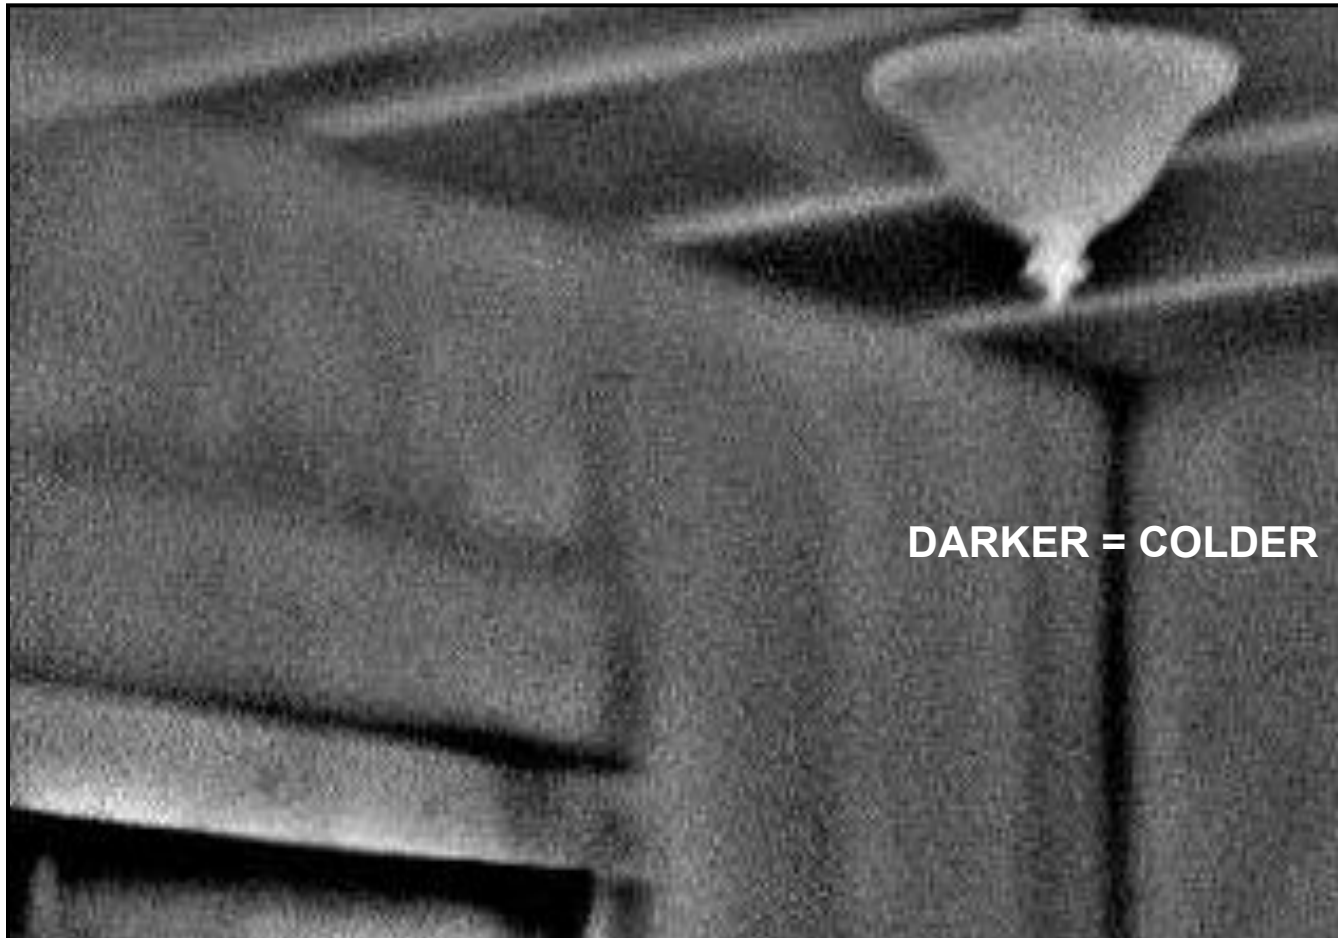
- **Blower door depressurization to expose thermal bypasses and air-leakage pathways through the framing**
- **Thermal imaging using Infra-red to identify changes in surface temperature resulting from bypasses and air-leakage**

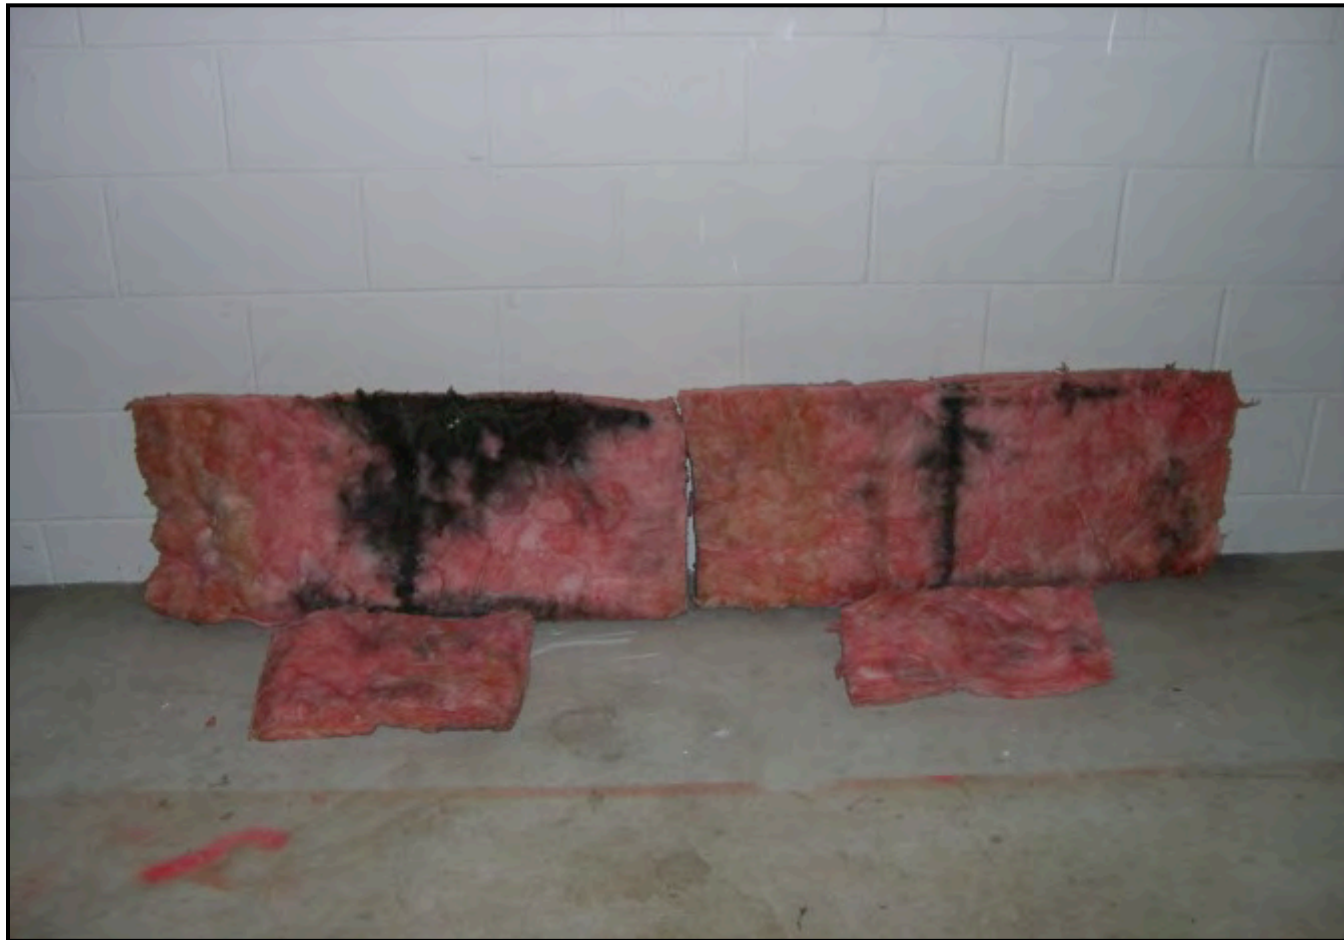
. . . and all dirt and debris was removed from all of the cavities

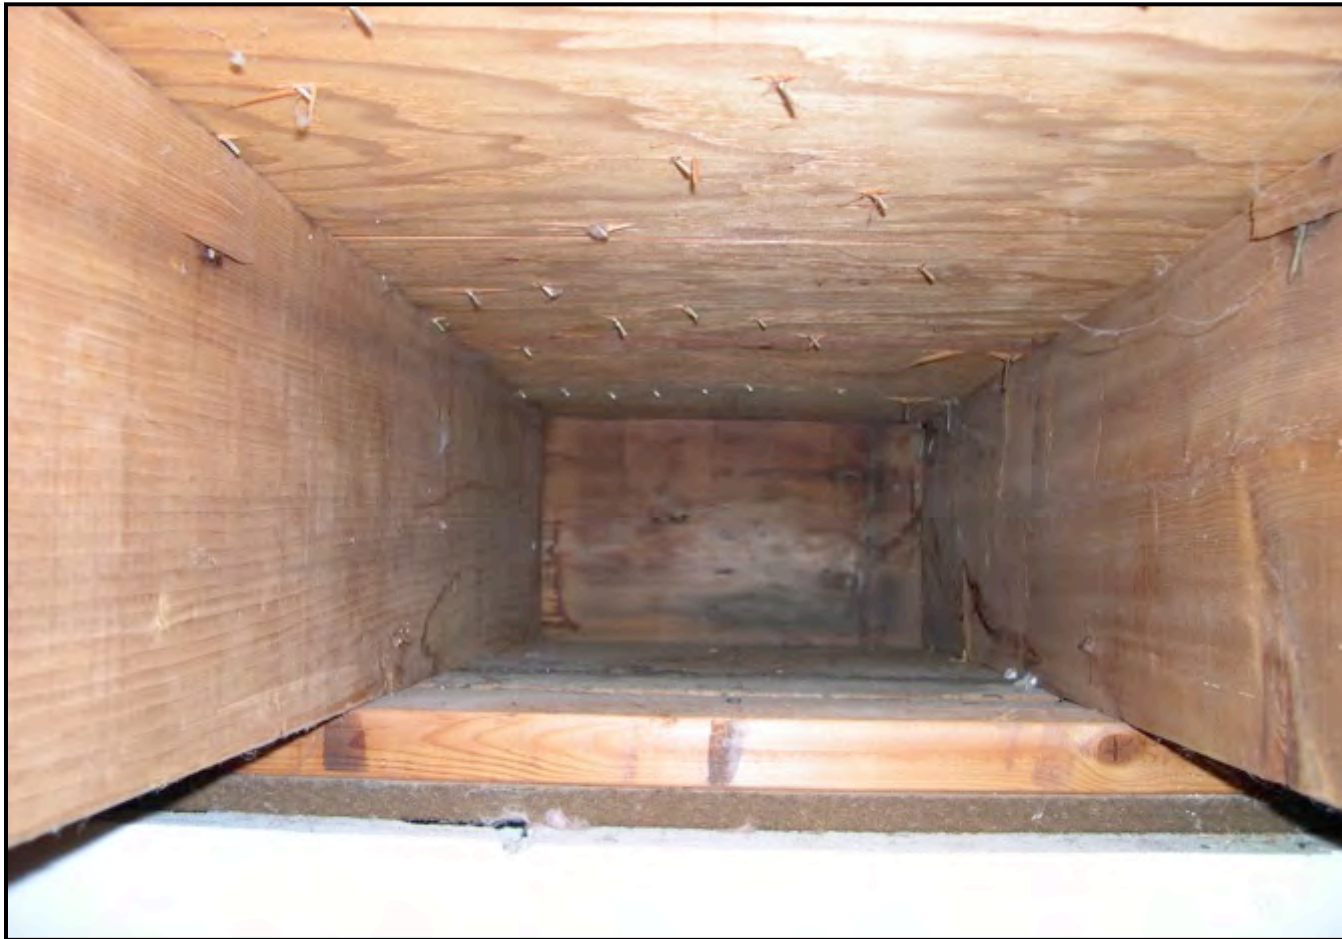
. . . was held against the weather-stripping in each cavity with spring wires

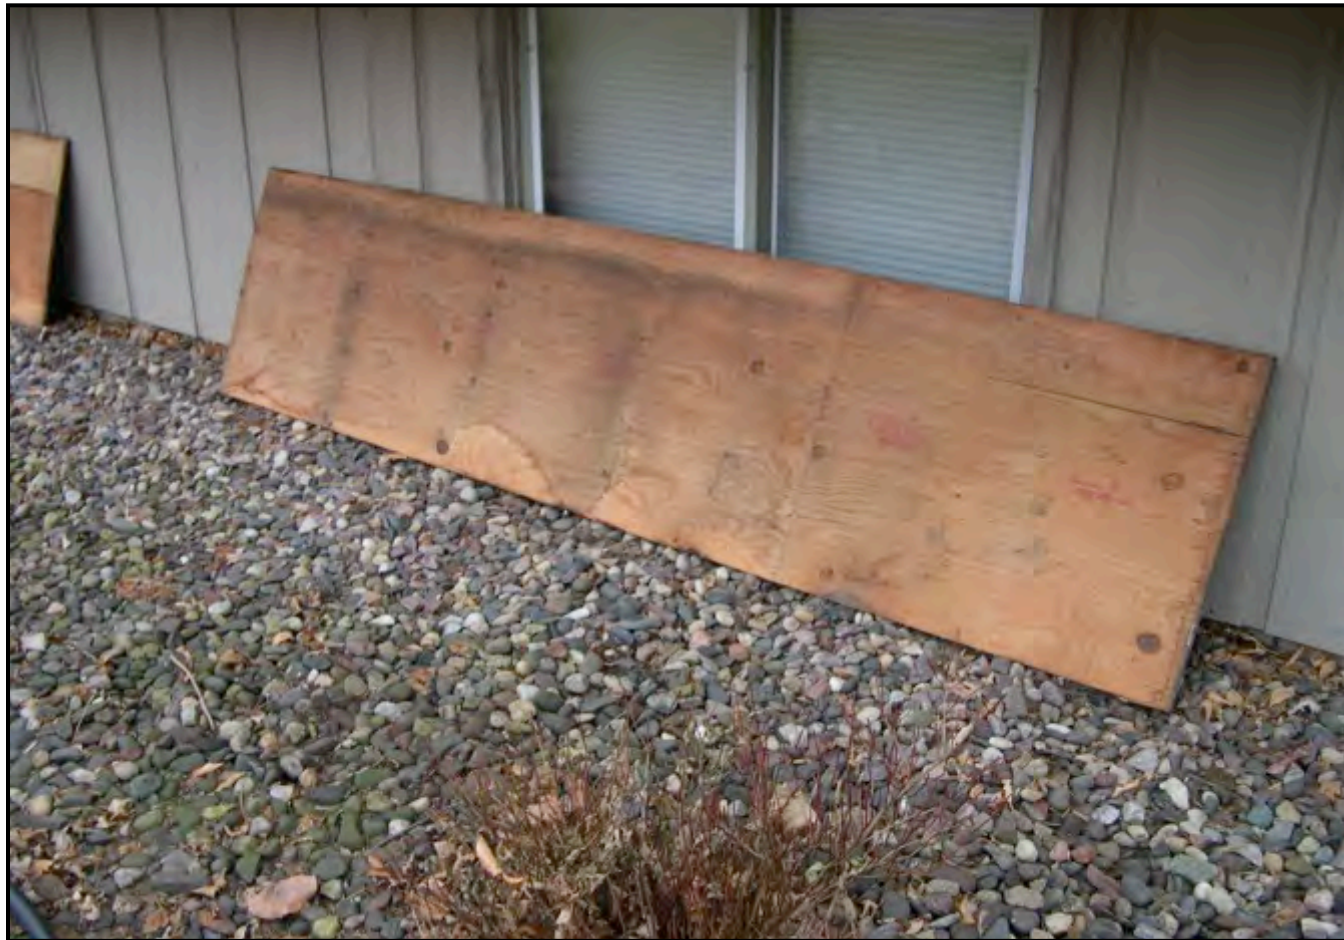
. . . but all components of the cantilevered floor were still sound

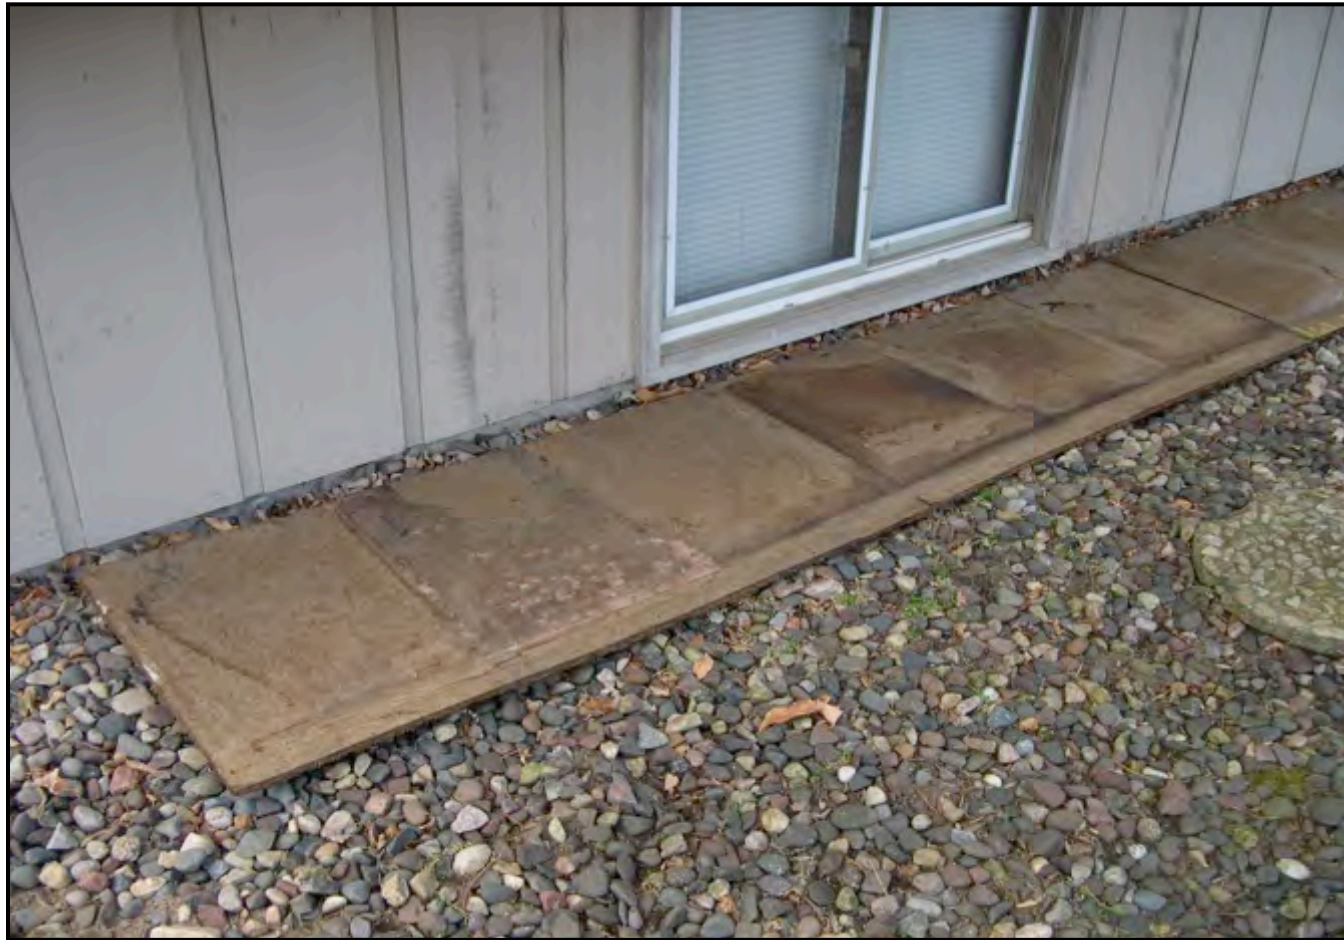
. . . and also showed evidence of water staining and infiltration

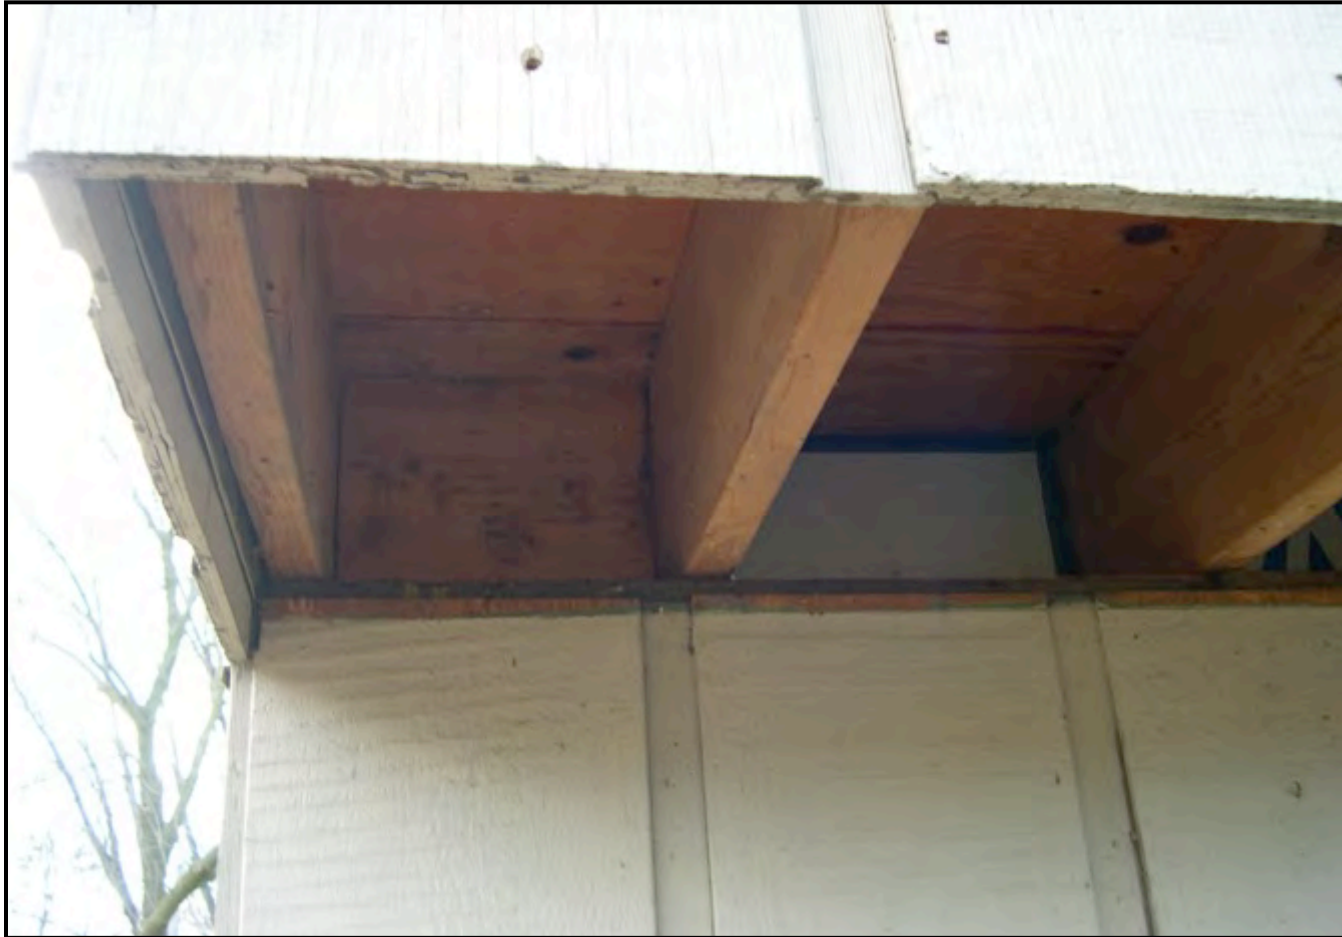
. . . for inspection, retrofit, and installation of research components

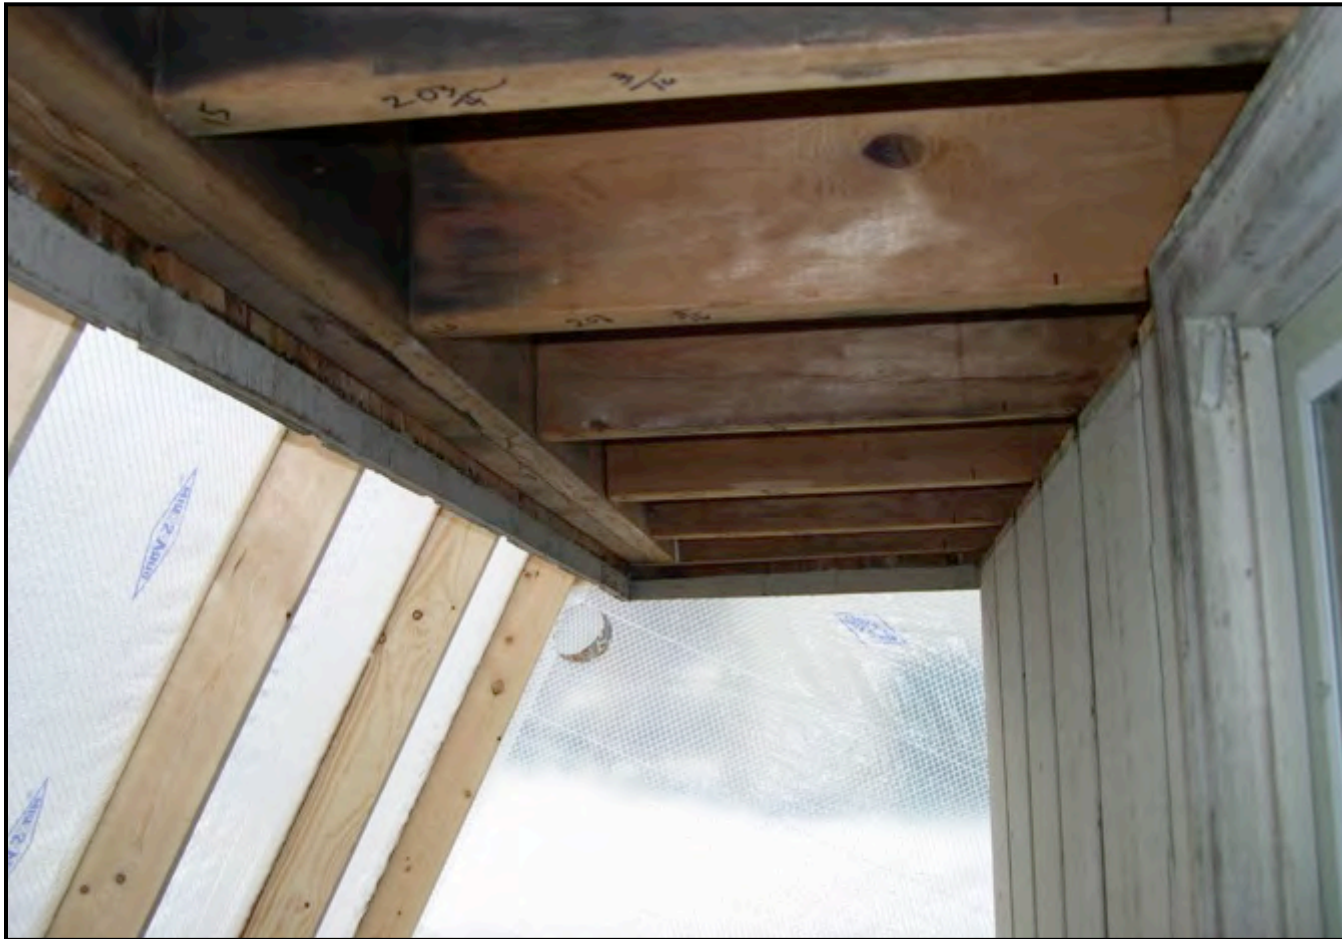
. . . so the research retrofit build-out could continue into the winter

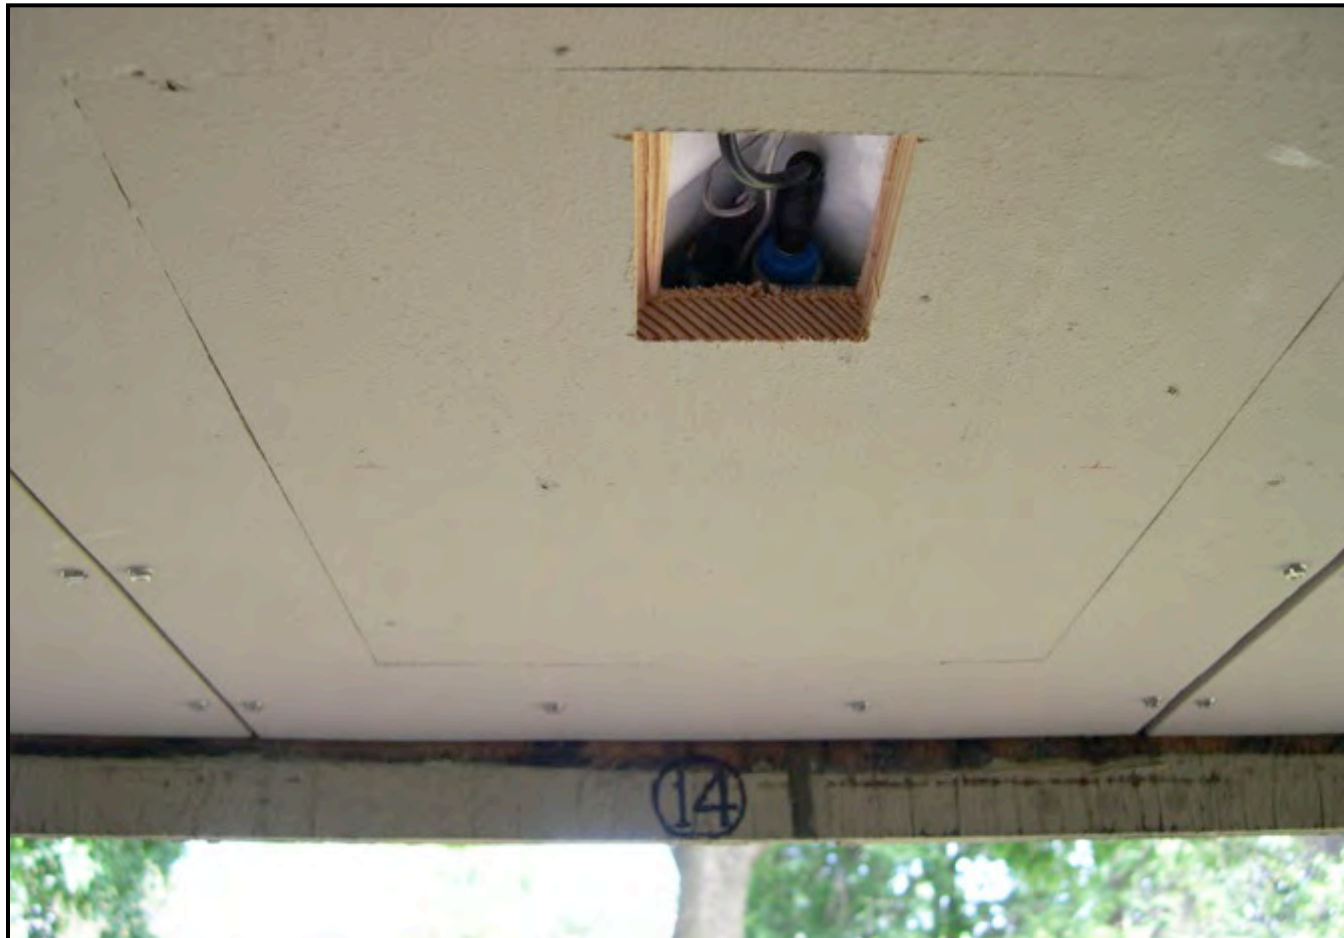
. . . was located between the two transmitter arrays
