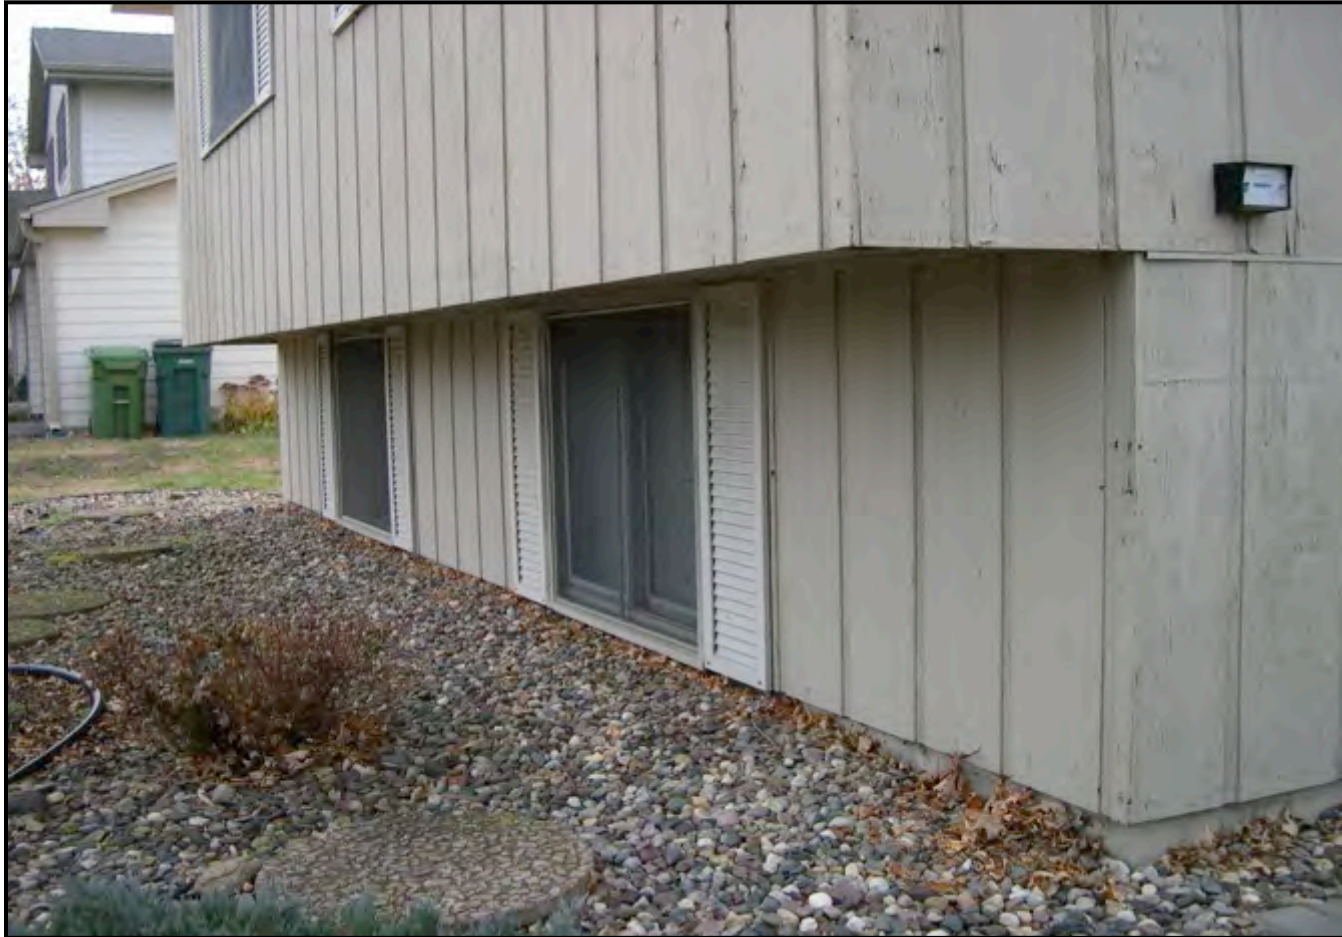
Extended floor has 2x10 fir joists at 16 inches on center

Cantilevered floor in “as found” condition

Variety of fiberglass batts “stuffed” into cavities in varying configurations

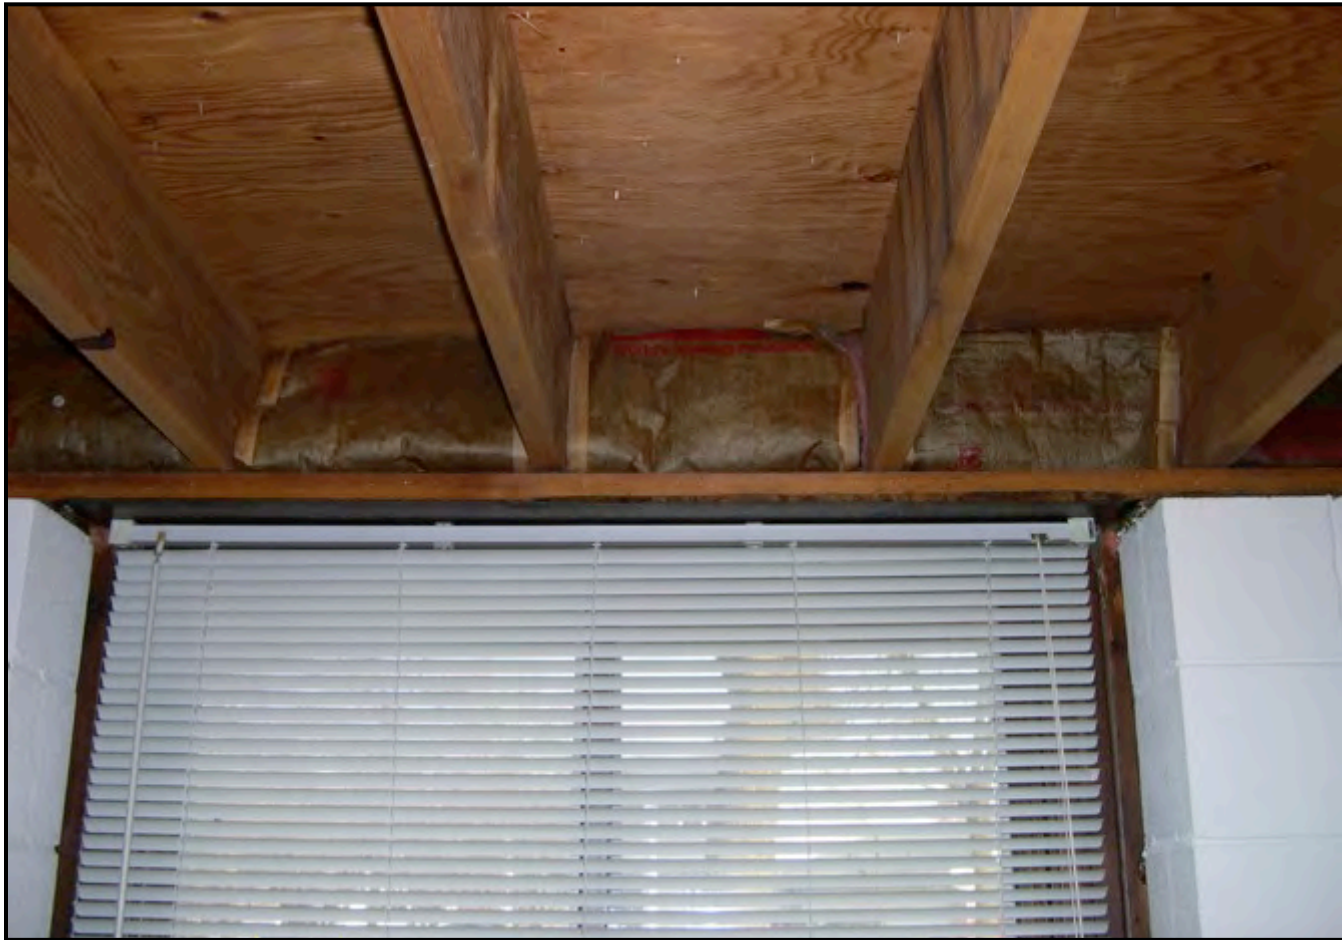
. . . and all dirt and debris was removed from all of the cavities

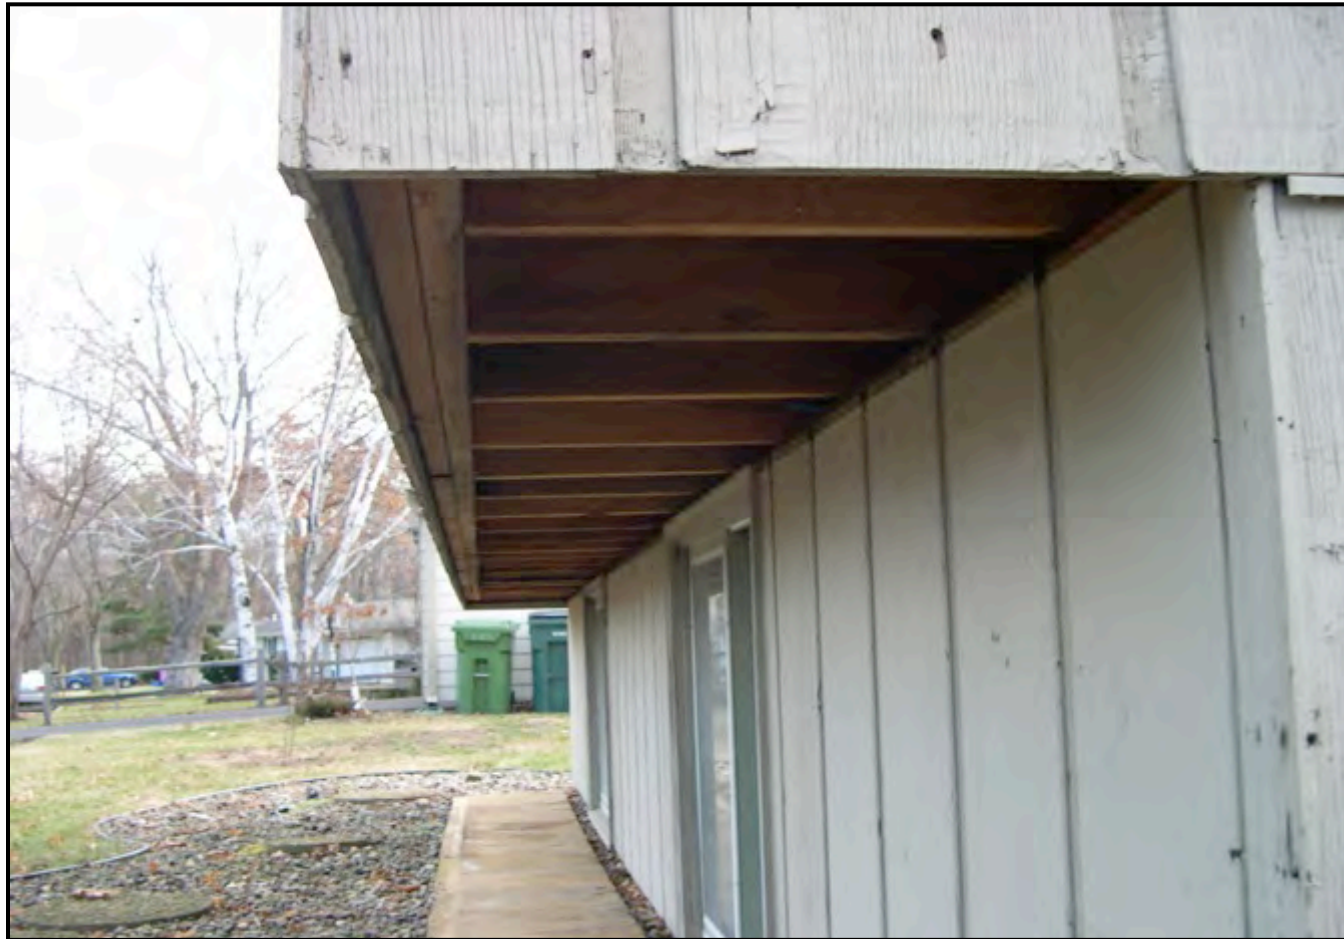
. . . for inspection, retrofit, and installation of research components

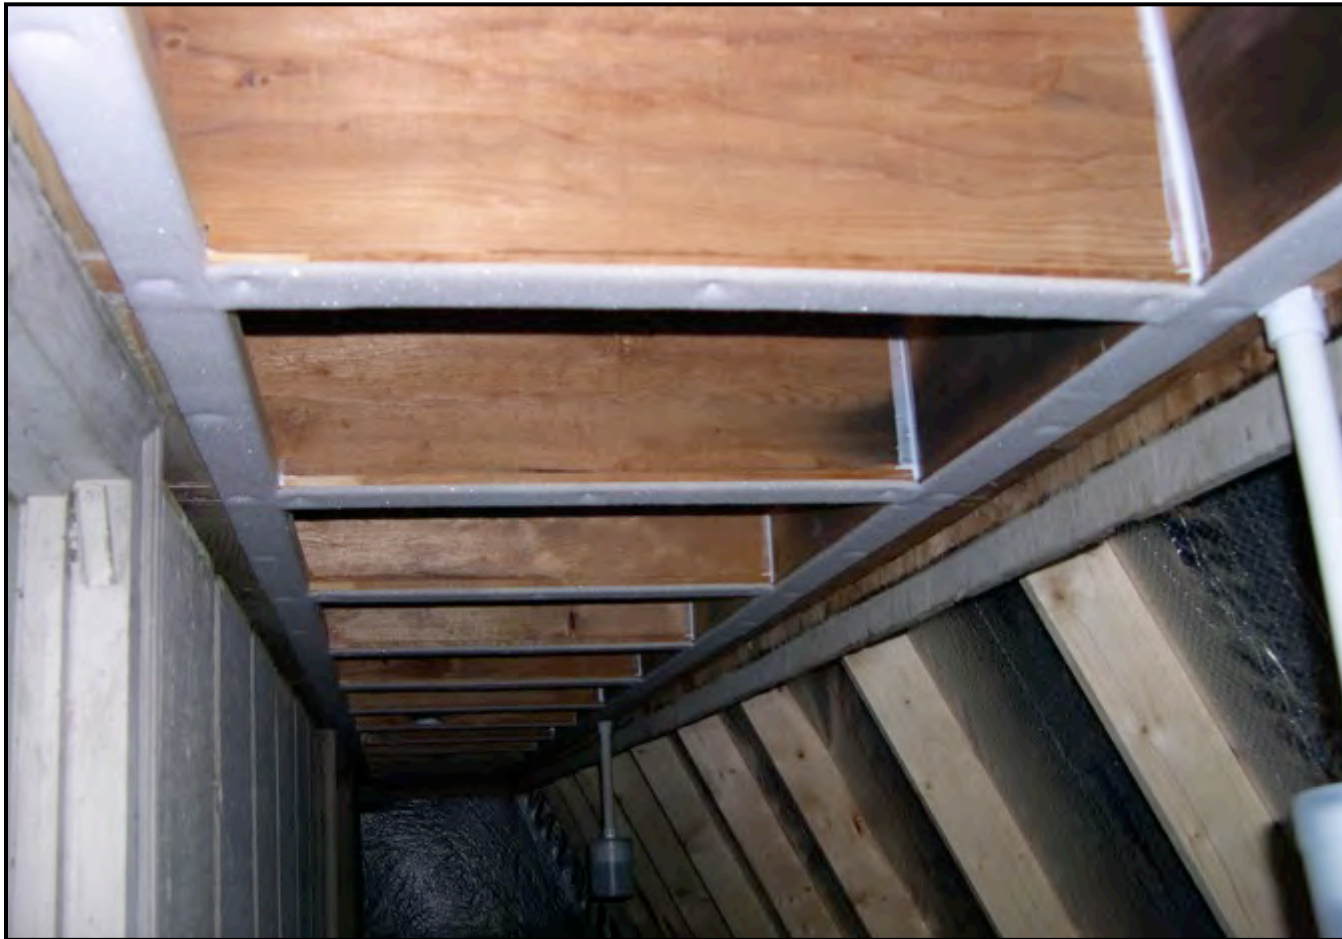
Air-sealing of the cantilevered floor cavities. . .

. . . was completed with silicone sealant at seams and closed cell foam gaskets
